CUI, a problem along the top edge of the support ring on CO GEN Stack #2..... occurred as a result of the failed caulk joint.

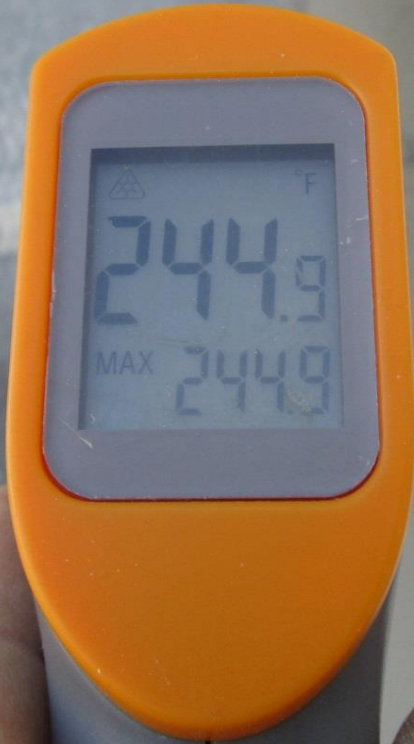
01/29/2015 07:54

Ground level stack
temp.

Rolled on application (not recommended) approx 120-150 mils. Resulted in approx 90 deg F drop in temp.

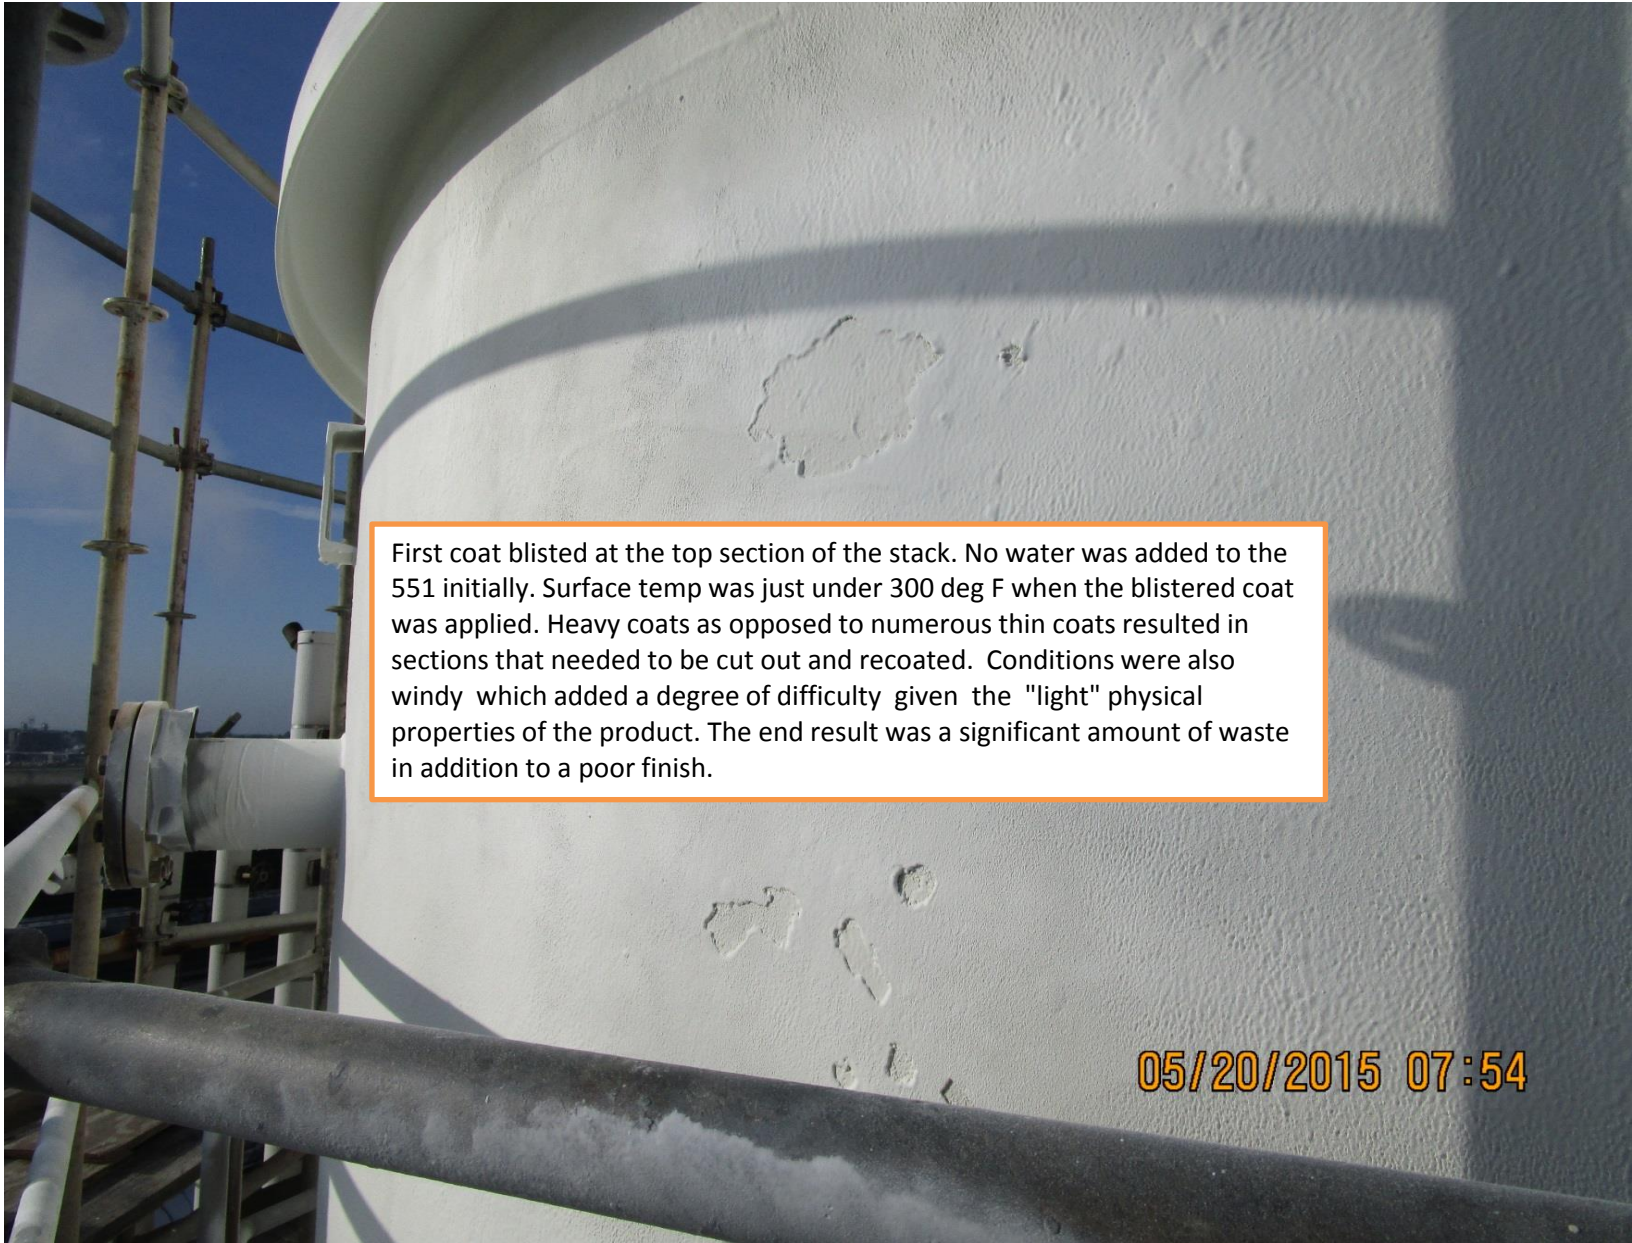
05/20/2015 07:54

First coat blistered at the top section of the stack. No water was added to the 551 initially. Surface temp was just under 300 deg F when the blistered coat was applied. Heavy coats as opposed to numerous thin coats resulted in sections that needed to be cut out and recoated. Conditions were also windy which added a degree of difficulty given the "light" physical properties of the product. The end result was a significant amount of waste in addition to a poor finish.

CUI condition eliminated. Upon bringing the temp up on the stack the surface of the 551 yellowed. 700 Siloxane was applied thereafter.

During the next CO GEN TA on stack #3, millage will be built up inside a range just above head height and just below the waist. Resulting in greater millage where it's needed, requiring the same amount of material or even less. Achieving a greater temp reduction.
