Product Case History

Carboguard 995 Hopper Car Lining - 8 years in service

AREA COATED: Interior of plastic pellet hopper cars in polyethylene service

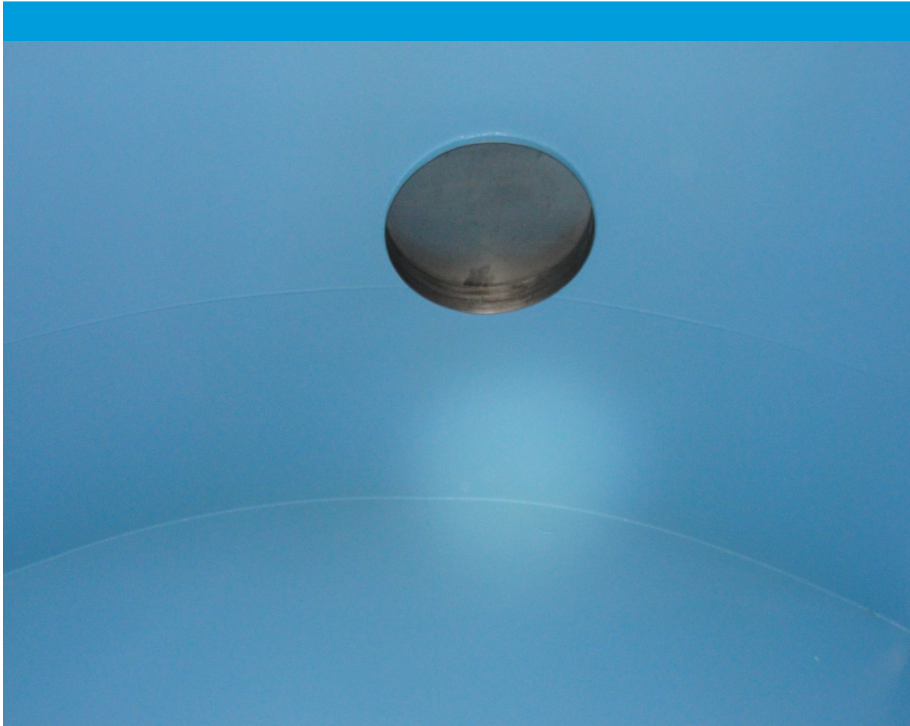
Carboguard 995 is a 100% solids flexible epoxy lining for use in food grade and plastic pellet service. This lining offers product purity and corrosion protection. At 8 years the lining condition was great, no wear or cracking was noticed in all four compartments.

The dry film thickness averaged 9 - 10 mils.
