## **Product Case History**

## 15 Year Old Carbothane DTM Urethane on a Tankcar

AREA COATED: Exterior surfaces of a Tank Car

PRODUCTS: Carbothane 8812

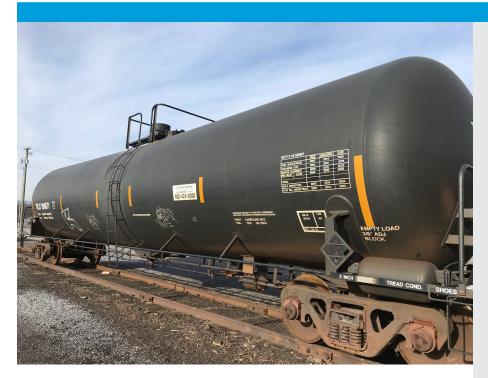
A Tank Car coated Carbothane 8812 in August of 2003 was inspected in December 2018. The coating was in excellent condition with no corrosion. The overall appearance was great and there was still a slight level of gloss with no chalking.
